IN RE: ETHICON, INC., PELVIC REPAIR SYSTEM PRODUCTS LIABILITY LITIGATION	Master File No. 2:12-MD-02327 MDL 2327 JOSEPH R. GOODWIN U.S. DISTRICT JUDGE
THIS DOCUMENT RELATES TO: <i>Janice Green v Ethicon, Inc., et al</i> Case No. 2:12-cv-02148

Case Specific Report of Shelby F. Thames, Ph.D.

Janice Green v. Ethicon

June 17, 2016

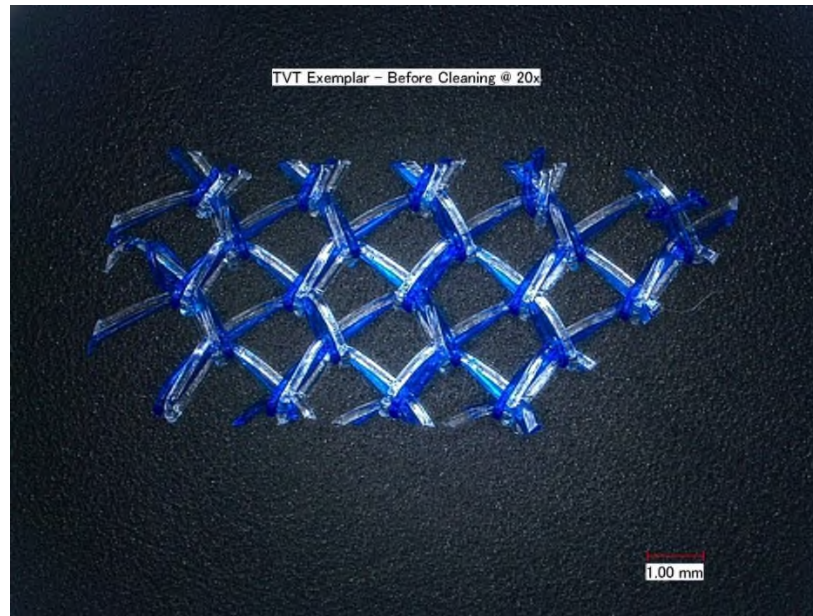
Figure 2. Pristine TVT mesh (810041B, # Lot 3694576) – Before Cleaning

The “Before Cleaning” samples were examined via light microscopy (LM), scanning electron microscopy (SEM), and Fourier transform infrared microscopy (FTIR-Micro). Figure 2 illustrates the appearance of a pristine TVT mesh (810041B, # Lot 3694576) sample. Light microscopy analysis (Figure 3, 4, and 5) depicts the extent to which the explanted meshes were tissue encapsulated.

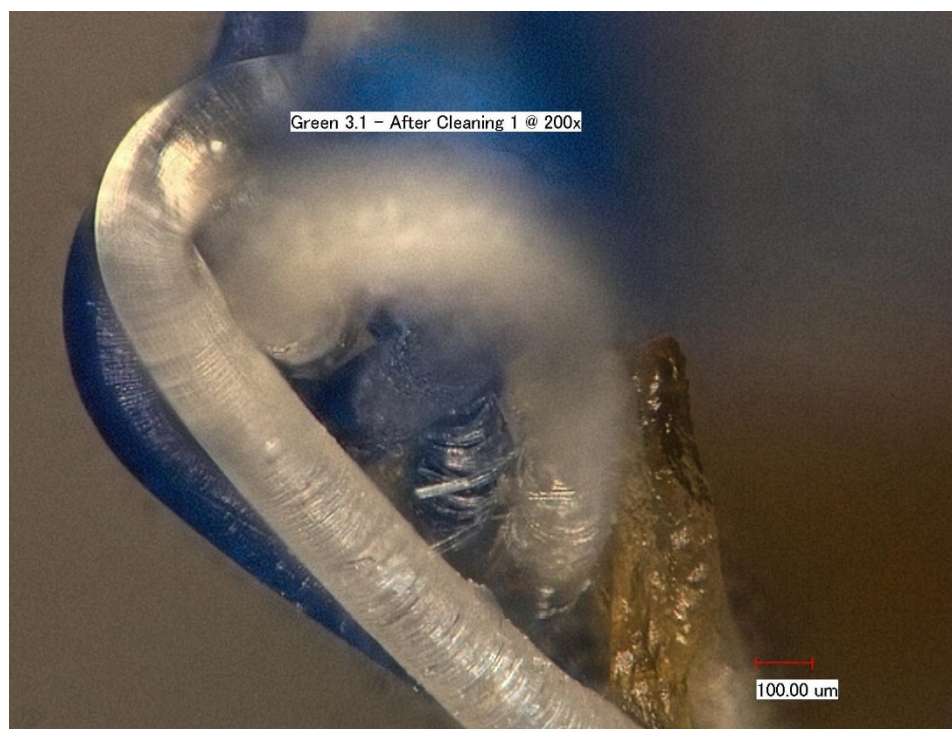
Higher magnification (100 – 200X) LM of the Prolene explants are shown encased within a dry and cracked, proteinaceous mass Before Cleaning and After Cleaning 1. Explant 2.1 is shown in Figures 5 and 6 and Explant 3.1 is shown in Figures 7 and 8.

Figure 8. Green 3.1 – After Cleaning 1 @ 200X

undergoes surface cracking which leads to these property losses. However, if one simply examines Figures 7 and 8 it is obvious that surface cracking and peeling occurs on both Prolene clear (unpigmented) and blue (pigmented) fibers. Plaintiffs contend the surface cracking material is degraded Prolene. However, this cannot be true. For instance, if the surface cracking and peeling material is degraded Prolene, likewise the pigmented (blue) and supposedly degraded surface and cracking material would be blue. In the same way, the clear and unpigmented degraded Prolene clear fibers would be clear. That is not the case. The LM data shows unequivocally the material peeling on both the clear and blue Prolene fiber is translucent under light microscopy, and proves therefore that Prolene does not degrade/oxidize *in vivo*. Simply put, if the blue Prolene fiber degraded its degradation products would be blue, and no such material exists. What does exist, however, are translucent flakes of “formalin-fixed” proteins that form around the Green 3.1 explant (see Figure 8).

These findings clearly do not support plaintiff's theory that the cracked material is degraded Prolene. Instead, the LM data are proof positive that the cracked and peeling product is not Prolene. Figure 8 is an excellent example describing the presence and appearance of formalin-protein flakes covering both Prolene blue and clear fibers. FTIR has identified the translucent flakes as protein derived in composition, and not oxidized or degraded Prolene. These data are consistent with formation of a protein-formaldehyde composite coating around all Prolene fibers, blue and clear.
